# Manhole Inspection Summary

Manhole # S25YY\_009MH

Insp Date: **6/18/07 10:33 PM**

**Location** Address: **1343 CLIPPER HEIGHTS AVE**

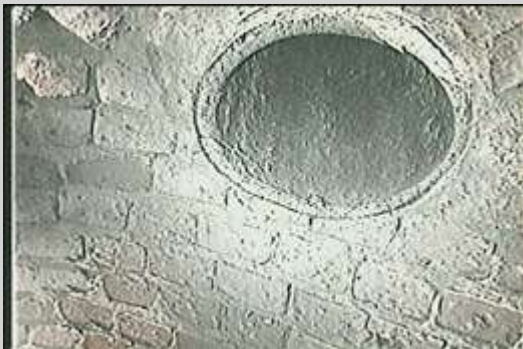
### 8 in. Circular Gravity Sewer Pipe In @ 3 O'Clock

Pipe Material: **Clay** ☐ Pipe Lined

Invert Depth: **7.10** (ft.) Flow Characteristics: **Slow**

Infiltration: **None** Pipe Seal Cond: **Unknown**

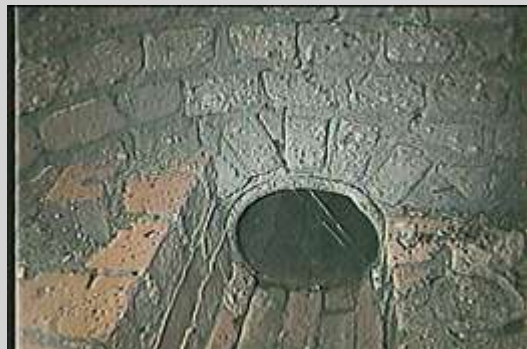
8 in. Circular Gravity Sewer

Pipe Material: **Clay**

Infiltration: **None**
